751314: Suzuki Splash, Opel Agila 04/2008 -

WORKSHOP MANUAL

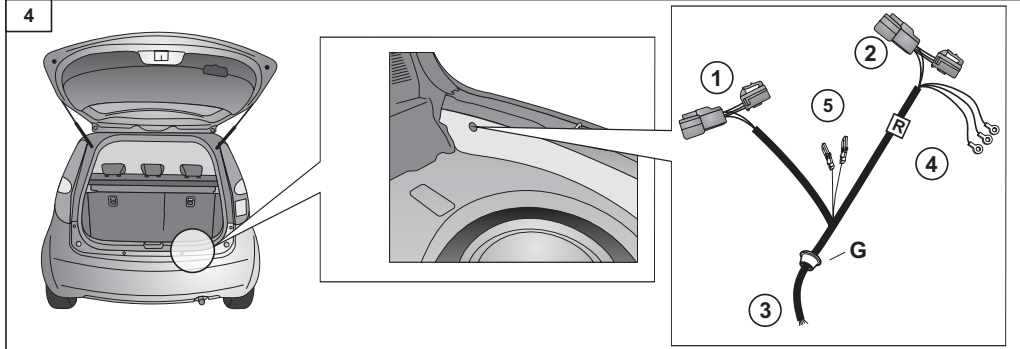
ROUTING

The diagram shows a cable with five numbered points: 1 (top left), 2 (top right), 3 (bottom left), 4 (top right), and 5 (bottom right). To the right is a rear view of a car with its trunk open, with callouts 1-5 pointing to specific locations in the trunk area.

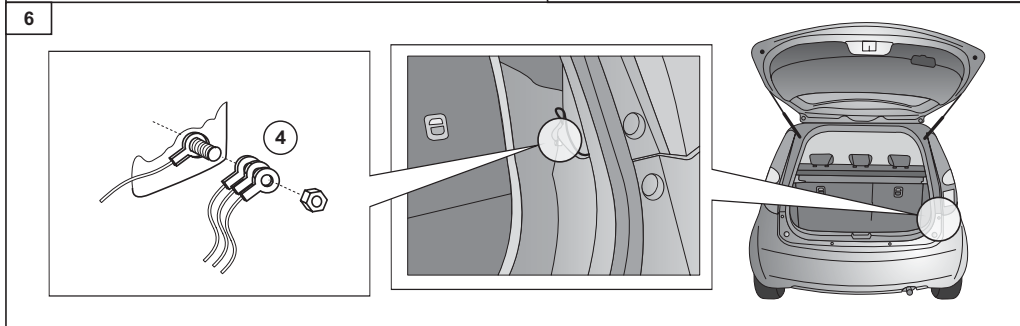
2 Suzuki Splash

The diagram shows a rear view of a Suzuki Splash with its trunk open. A callout shows a close-up of a hole in the trunk panel, with a circular cap being placed over it.
